Contract #: 04-0120F4Cty: SF/ALA Rte: 80 PM: 13.2/13.9File #: 69.28**WELDING INSPECTION REPORT****Resident Engineer:**Pursell, Gary**Address:** 333 Burma Road**City:** Oakland, CA 94607**Report No:** WIR-001500**Date Inspected:** 14-Feb-2008**Project Name:** SAS Superstructure**OSM Arrival Time:** 700**Prime Contractor:** American Bridge/Fluor Enterprises, a JV**OSM Departure Time:** 1500**Contractor:** Zhenhua Port Machinery Company, Ltd (ZPMC), Changxing Island **Location:** Shanghai, China

Bridge No: 34-0006**Component:** Tower Mock-ups and OBG**Summary of Items Observed:**

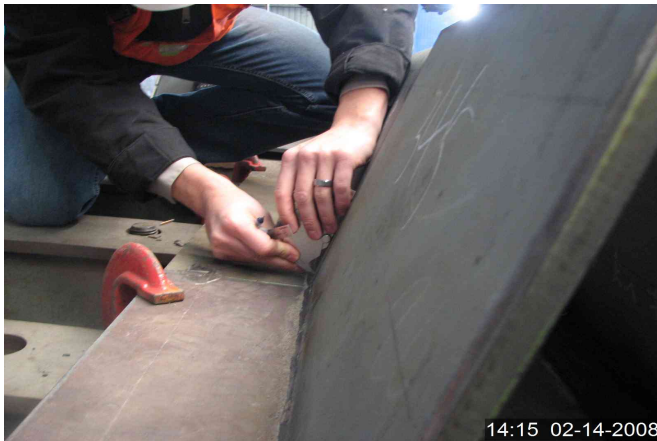
The Quality Assurance Inspector was present for production monitoring tests scheduled for 0800. The Quality Assurance Inspector randomly performed an inspection of the joint preparation and observed rough bevels and rust in the root area as illustrated in the digital photograph below. An incident report was generated pertaining to the issue. The commencement of the ZPMC production monitoring tests did not start until 1040. The Quality Assurance Inspector observed ZPMC Quality Control Inspector Sun Wei monitoring the welding. The welding

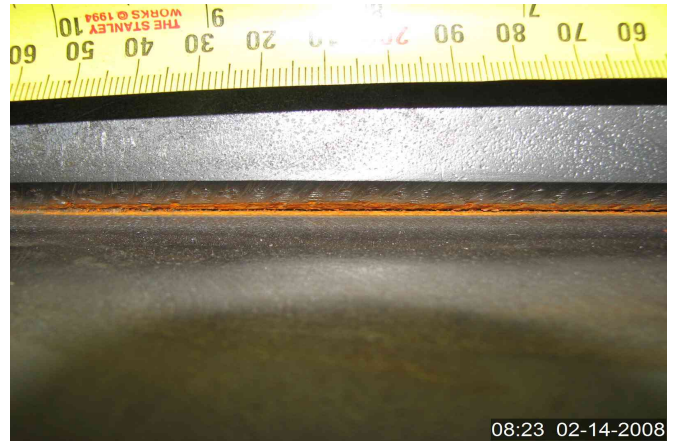
parameters were recorded in an on site log for future review. After the gas metal arc welding root pass was complete ZPMC was observed grinding the tack weld areas in preparation for the submerged arc welding cover pass. Below is a digital photograph illustrating the grinding in progress. ABF representative Warren Buehler was observed measuring the amount of under fill upon completion of the PMT. Below is a digital photograph of Mr. Buehler utilizing a bridge camber gauge to obtain the measurement. The submerged arc welding of three closed ribs for qualification of six welding operators was completed at 1410. There were various representatives from ZPMC/ABF and Caltrans present.
